**JOB No.: TCS01216/21**

**WSD Contract No.: 3/WSD/20 -  
Reclaimed Water Supply to Sheung Shui and Fanling**

**MONTHLY ENVIRONMENTAL MONITORING & AUDIT  
REPORT (NO.41) – APRIL 2025**

**PREPARED FOR  
WATER SUPPLIES DEPARTMENT**

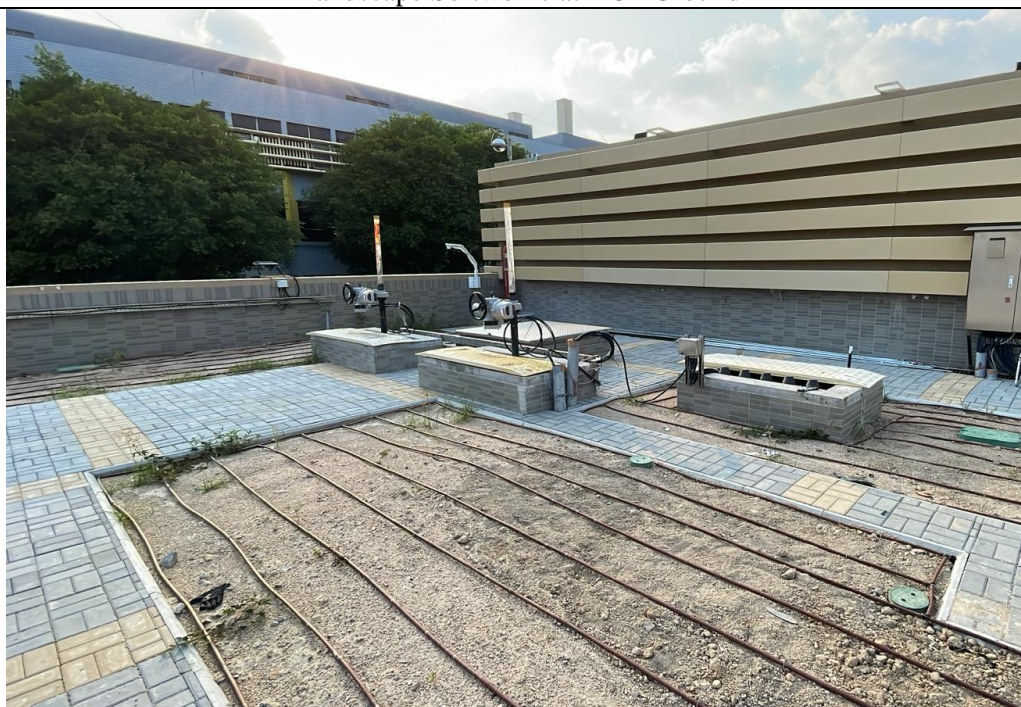
Covering of HCF Roof

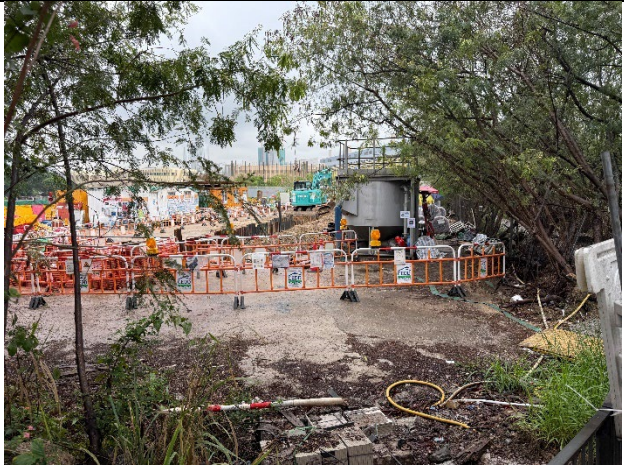
<b>Photo 1</b> Site conditions of the project site at P4 (25/4/2025)	<b>Photo 2</b> Site conditions at P6 (25/4/2025)

- 5.4 Excavation and water tanks were observed near the site entrance of the current project for the laying of drainage. Nevertheless, other construction and anthropogenic activities around the survey transects were still active during the reporting month and the following activities were noted (Photo 1 of **Appendix E**).

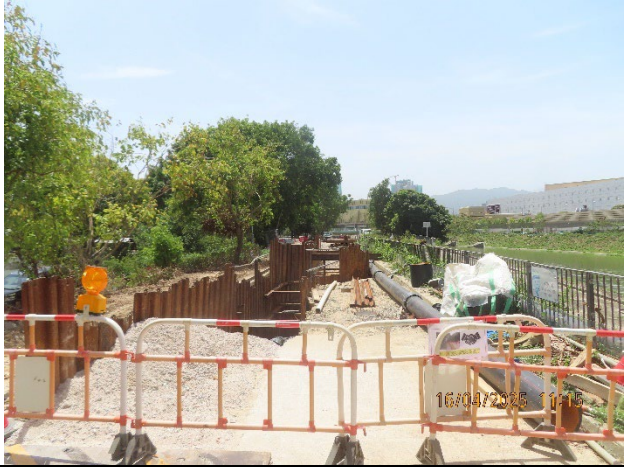
<b>Photo 3</b> Road works at T2 by DSD (16/4/2025)	<b>Photo 4</b> Riverbank being backfilled by CEDD at T3 (14/4/2025)

- 5.6 Road enhancement and sewerage system upgrade works by Drainage Services Department (DSD) along T2 near P3 were observed active throughout the surveying month, this construction extended

to P4 since the survey on 17 April 2024, where excavators have been in use. The current site condition is shown in Photo 3 of **Appendix E**, a new pipeline was laid in an excavated pit, which was mostly back filled.

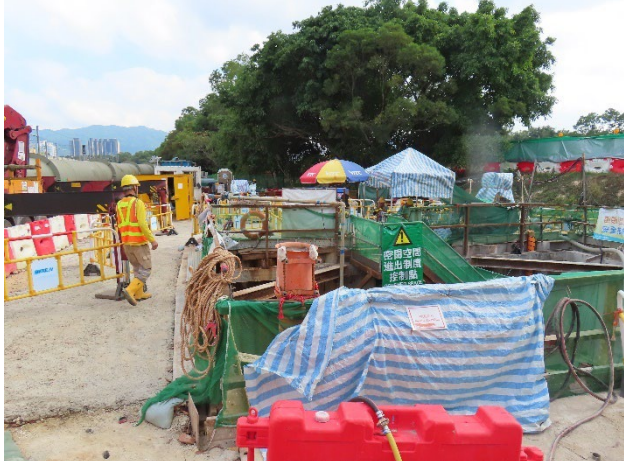
<b>Photo 5</b> Construction works owned by BKREJV at T3 (22/4/2025)	<b>Photo 6</b> Cattle Egrets at T6 (16/4/2025)
