**WSD Contract No.: 3/WSD/20 -
Reclaimed Water Supply to Sheung Shui and Fanling**

**MONTHLY ENVIRONMENTAL MONITORING & AUDIT
REPORT (NO.51) – FEBRUARY 2026**

**PREPARED FOR
WATER SUPPLIES DEPARTMENT**

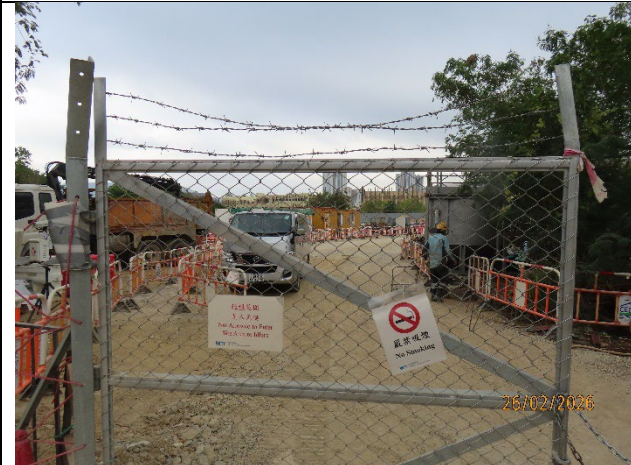
Photo 1 Site conditions of the project site at P4 (26/2/2026)
