**WSD Contract No.: 3/WSD/20 -
Reclaimed Water Supply to Sheung Shui and Fanling**

**MONTHLY ENVIRONMENTAL MONITORING & AUDIT
REPORT (NO.18) – MAY 2023**

**PREPARED FOR
WATER SUPPLIES DEPARTMENT**

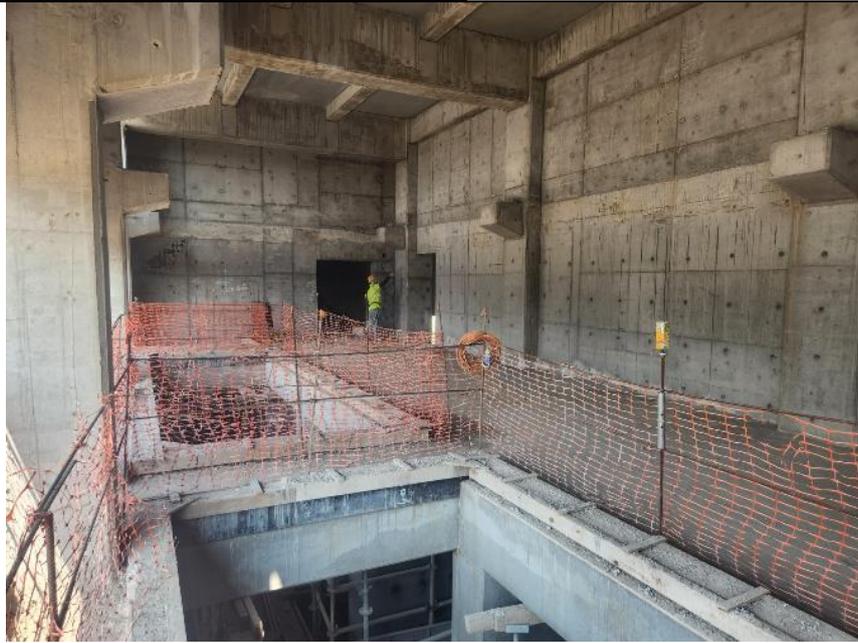
ABWF Works – ReWPS Ground Floor

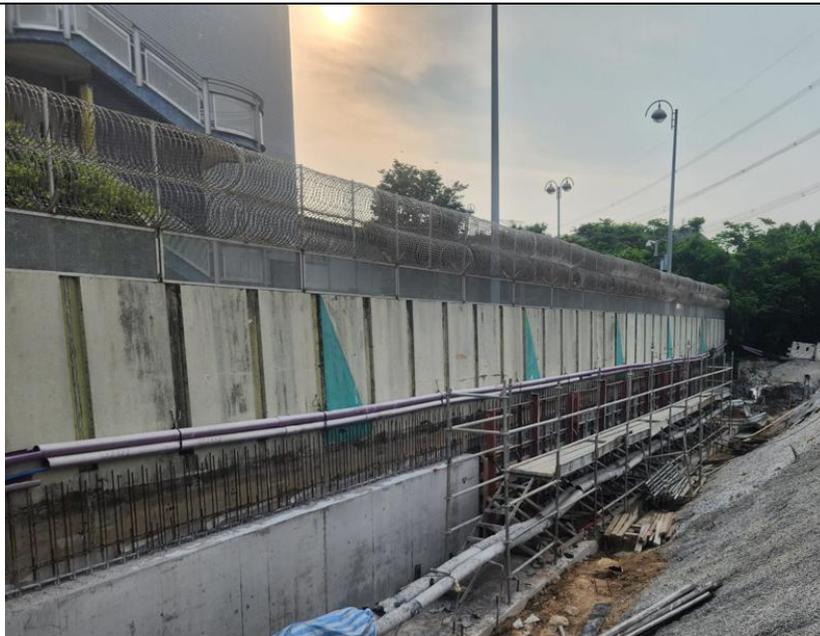
Fence wall at SWHWRP – Rebar fixing and Concreting work

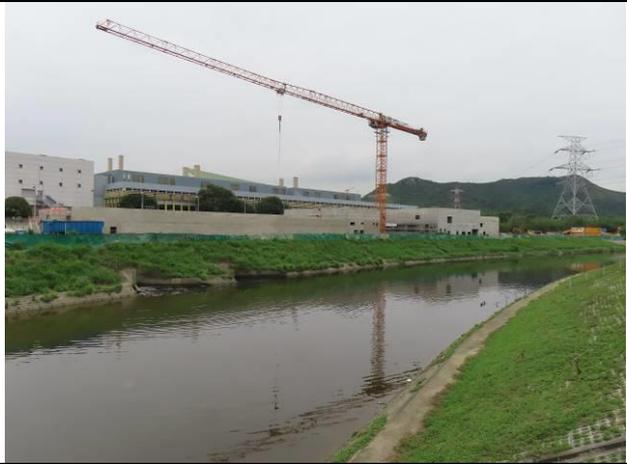
Photo 1 Works on current project at P4 (12/5/2023)	Photo 2 Inflatable dam maintenance and the repair by DSD at P2 progress on 31/5/2023

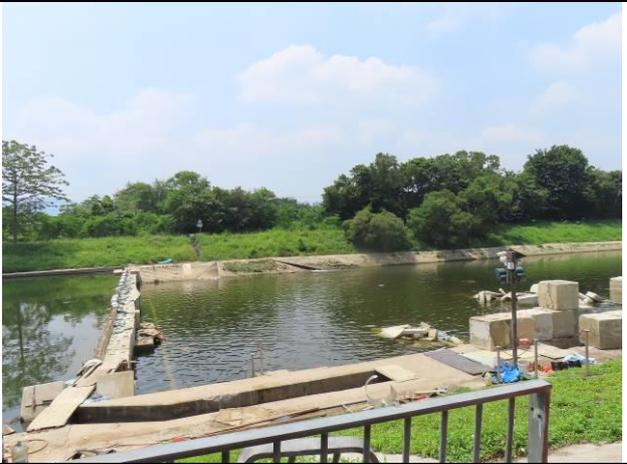
- 5.6 Since the survey dated on 4th November 2022, surveyors have recorded inspection and maintenance works of the inflatable dam at P2, these works were determined to be as part of the North East New Territories Sewerage System Upgrade led by Drainage Services Department (DSD). It was observed during the survey on 31st May 2023 (as seen in Photo 2 of **Appendix E**) that the maintenance was

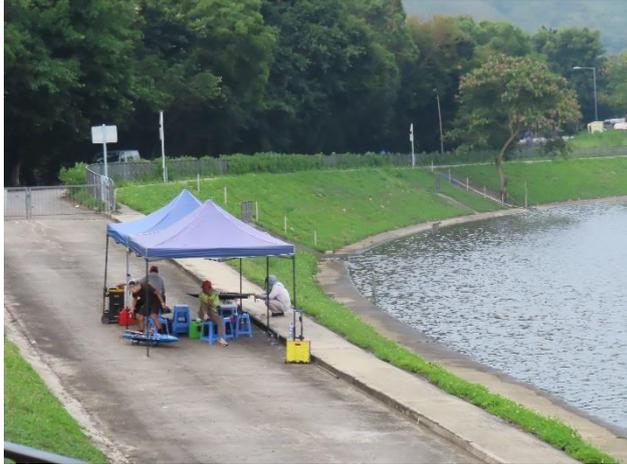
Photo 3 Remote control boat racing at P2 (1/6/2023)	Photo 4 Road enhancement works by DSD at T2 (5/5/2023)

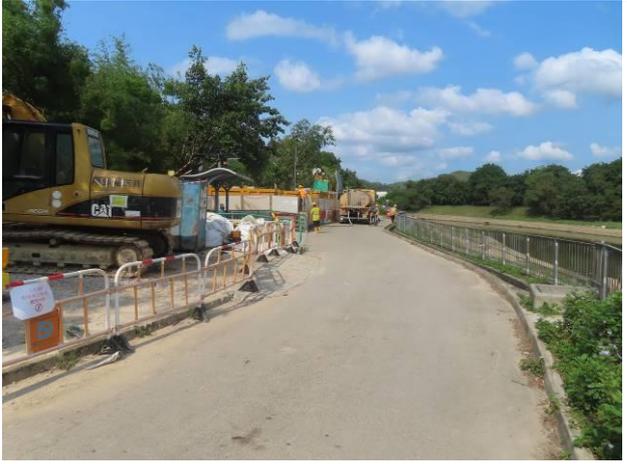
- 5.9 Road improvement works by DSD (Photo 4 of **Appendix E**) was also observed to remain active along T2 near P3, and large vehicles producing noise were seen to enter and leave the site. This may be a potential source of disturbance that discourages waterbirds from foraging at P3.

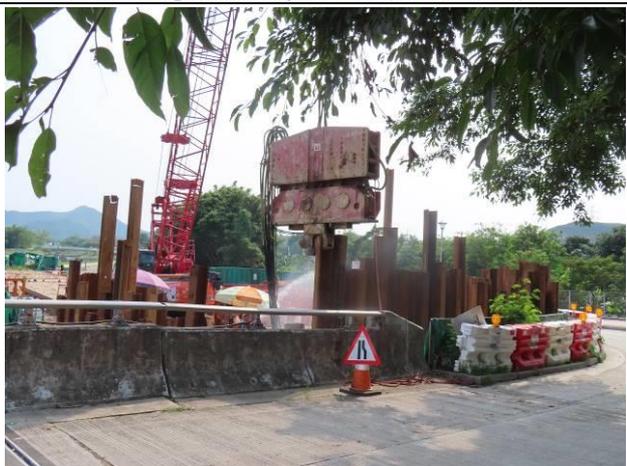
- 5.10 The construction by Civil Engineering and Development Department (CEDD) near P7 was observed active throughout the entire reporting month (Photo 5 of **Appendix E**).

Photo 5 Piling at P7 by CEDD (1/6/2023)	Photo 6 Great Egret at T2 (23/5/2023)
