**WSD Contract No.: 3/WSD/20 -  
Reclaimed Water Supply to Sheung Shui and Fanling**

**MONTHLY ENVIRONMENTAL MONITORING & AUDIT  
REPORT (No.43) – JUNE 2025**

**PREPARED FOR  
WATER SUPPLIES DEPARTMENT**

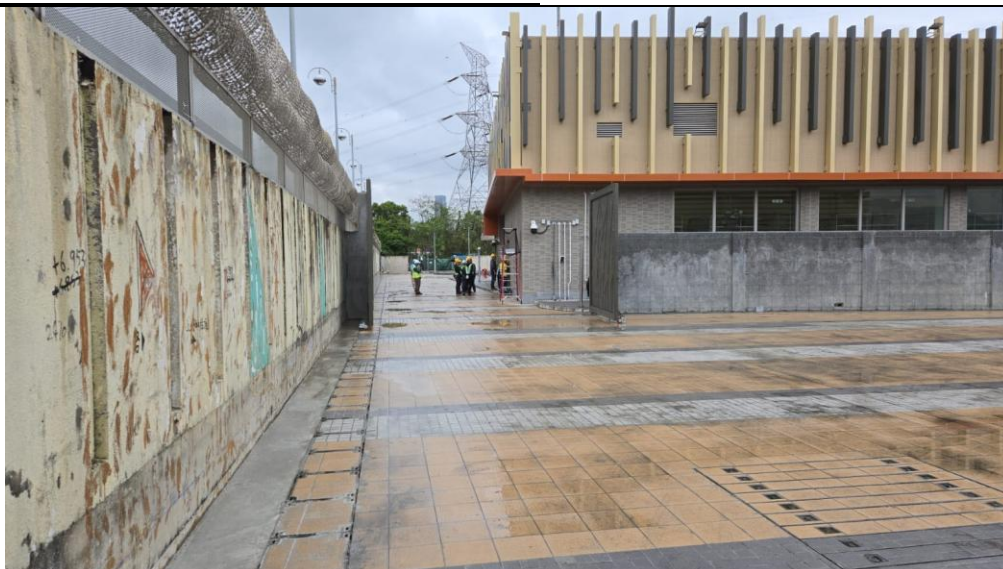
Gate 1 and Gate 2 Modification Works

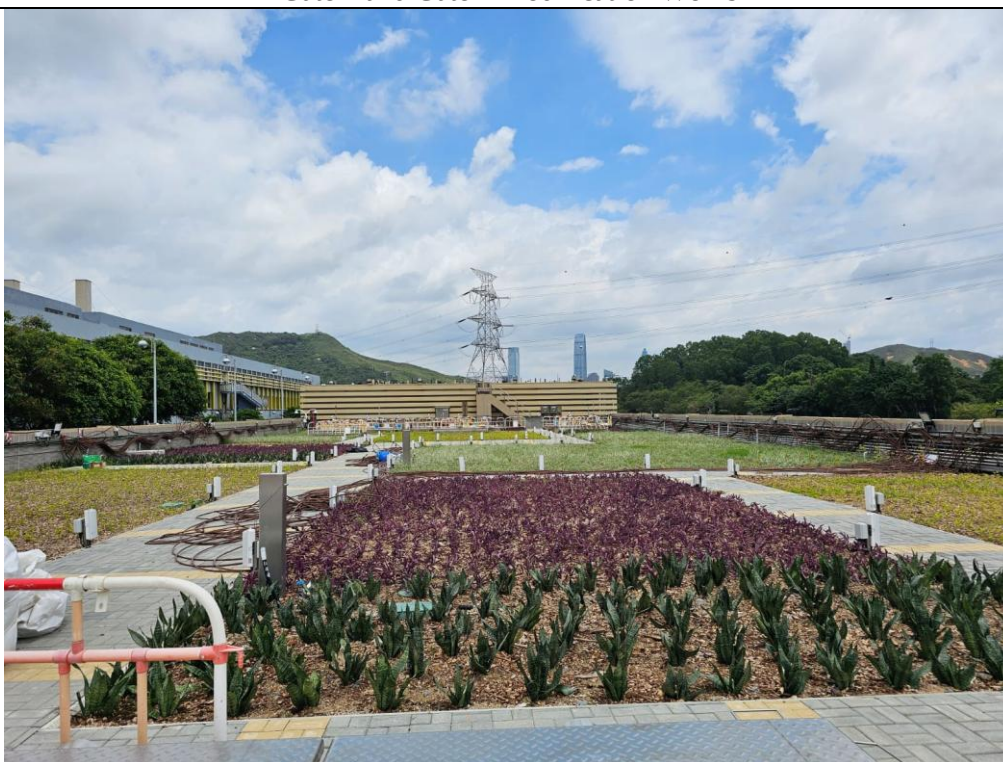
Landscape Softworks at HCF Roof

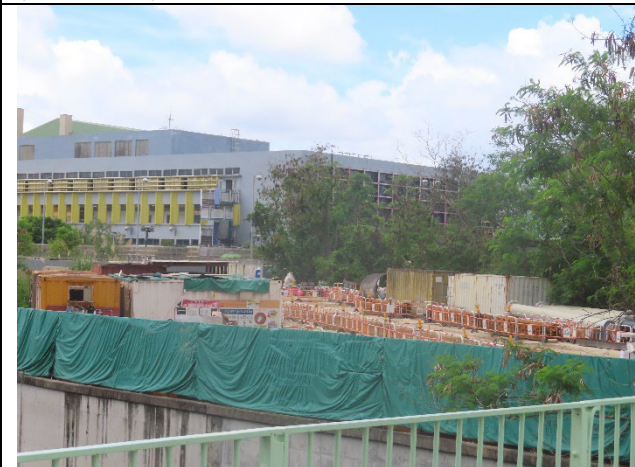
**Photo 1** Site conditions of the project site at P4  
 (23/6/2025)

- 5.2.4 It was noted Excavation and water tanks were observed near the site entrance of the current project for the laying of drainage. Other construction and anthropogenic activities around the survey transects are still active during the reporting month.

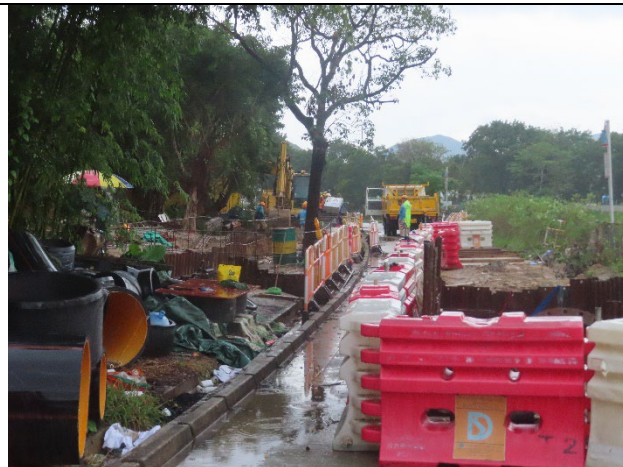
**Photo 2** Road works at T2 by DSD (13/6/2025)

- 5.2.7 Road enhancement and sewerage system upgrade works by other Project along T2 near P3 was observed active throughout the surveying month and has extended to P4 during the survey in April 2024. The use of excavators and crane trucks were also observed on 23<sup>rd</sup> May 2024 at P4 and P3 respectively, resulting in the increased disturbance level at these count locations.

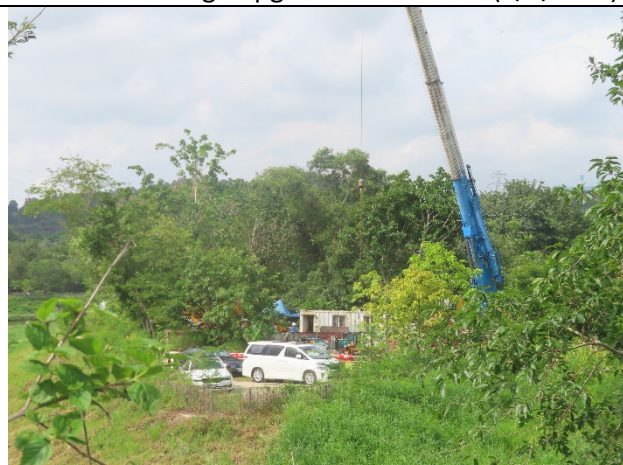
**Photo 4** Sewerage upgrade works at P5 (2/6/2025)

- 5.2.8 An extension of this sewerage system upgrade was observed to be in operation at the Eastern bank of Shek Sheung River near P5 since the survey in late August 2023. During the survey on 28 March 2025, it was observed that the construction extended to T1, where excavators and fencing were present. Machinery and stockpiles were observed within its construction area, which may be a potential source of disturbance that discourages birds from foraging near P5 and T1.

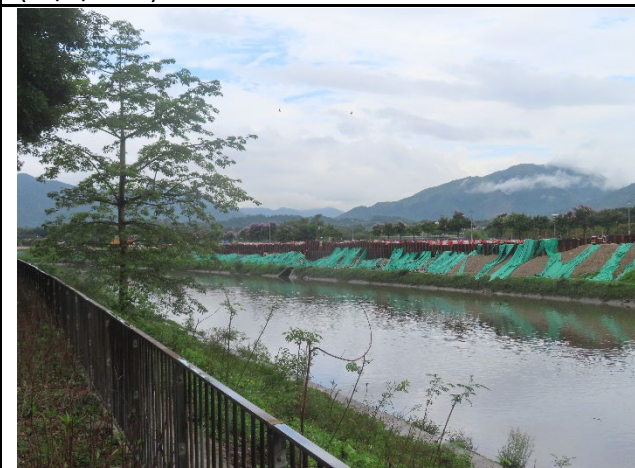
**Photo 5** Construction works owned by CEDD at T3  
 (13/6/2025)

- 5.2.9 The construction work by other Project near P7 was also observed active throughout the entire reporting month. Piling works of the same construction was also observed at T3, roughly midway between P6 and P7, and since the survey on 11<sup>th</sup> September 2023, excavators were observed on the opposite bank to the survey transect. Additionally, Construction works on the riverbank were observed since 31 December 2024, while various portions of the riverbank were being backfilled since the survey on 10 March 2025..
