**WSD Contract No.: 3/WSD/20 -
Reclaimed Water Supply to Sheung Shui and Fanling**

**MONTHLY ENVIRONMENTAL MONITORING & AUDIT
REPORT (NO.49) – DECEMBER 2025**

**PREPARED FOR
WATER SUPPLIES DEPARTMENT**

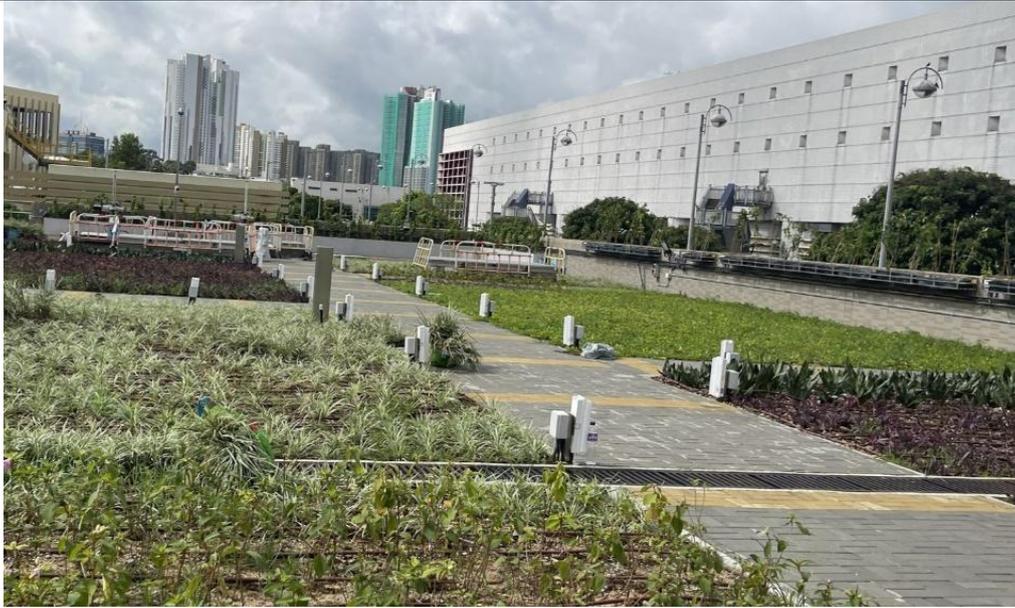
General View of HCF Roof

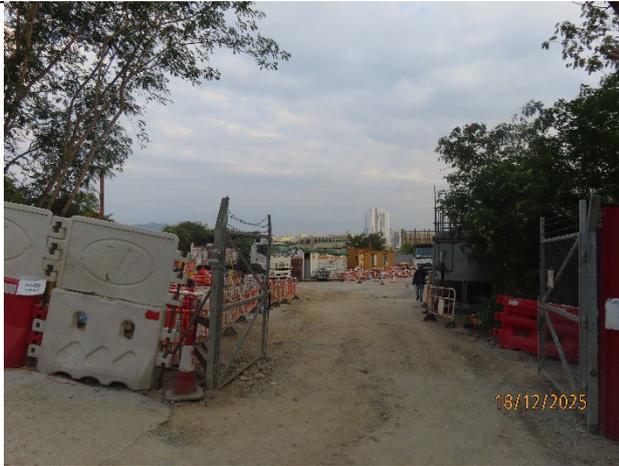
Photo 1 Site conditions of the project site at P4 (18/12/2025)	Photo 2 Road works at T2 by DSD (30/12/2025)

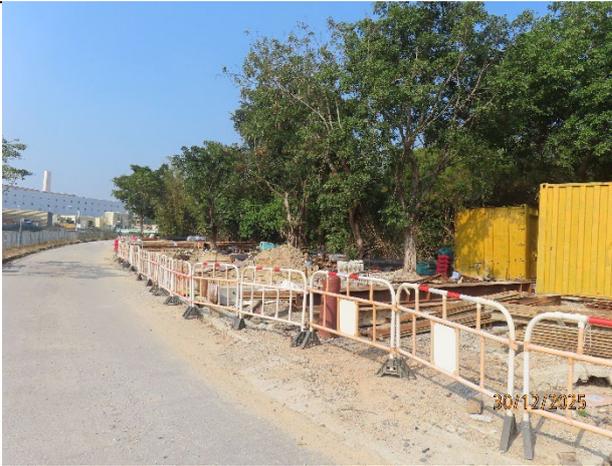
- 5.2.7 Road enhancement and sewerage system upgrade works by other Project along T2 near P3 was observed active throughout the surveying month. A new excavation has been observed since the survey on 11 July 2025, resulting in the increased disturbance level at these count locations.

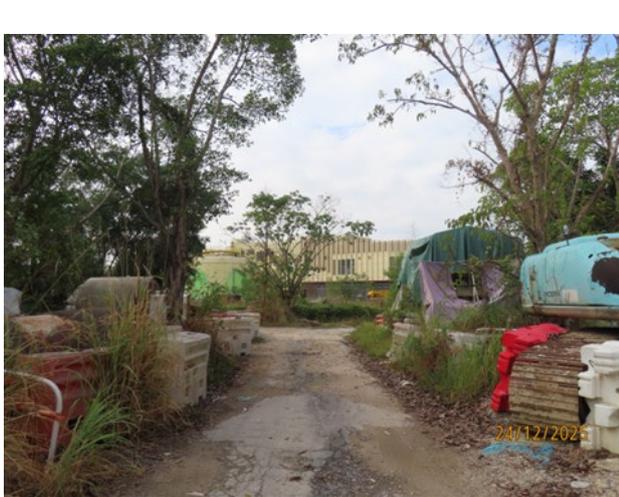
- 5.2.8 An extension of this sewerage system upgrade was observed to be in operation at the Eastern bank of Shek Sheung River near P5 since the survey in late August 2023. During the survey on 28 March 2025, it was observed that the construction extended to T1, where excavators and fencing were present. Machinery and stockpiles were observed within its construction area, which may be a potential source of disturbance that discourages birds from foraging near P5 and T1.

Photo 3 Machinery and stockpiles of sewerage system upgrade works at P5 (24/12/2025)	Photo 4 Construction by CEDD at T3 (4/12/2025)

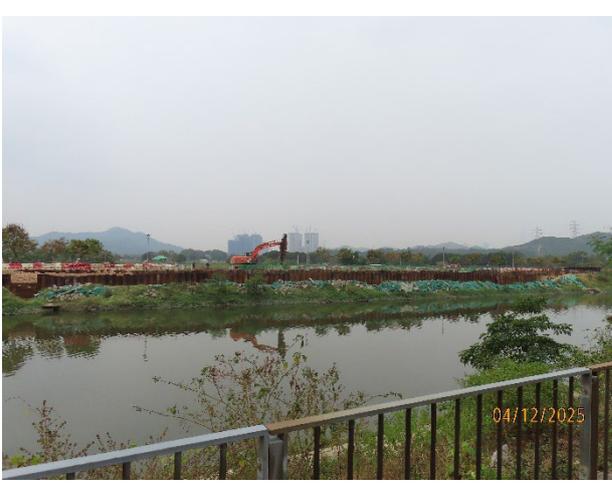
- 5.2.9 The construction work by other Project near P7 was also observed active throughout the entire reporting month. Piling works of the same construction was also observed at T3, roughly midway between P6 and P7, and since the survey on 11th September 2023, excavators were observed on the opposite bank to the survey transect. Additionally, Construction works on the riverbank were observed since 31 December 2024, while various portions of the riverbank were being backfilled since the survey on 10 March 2025.

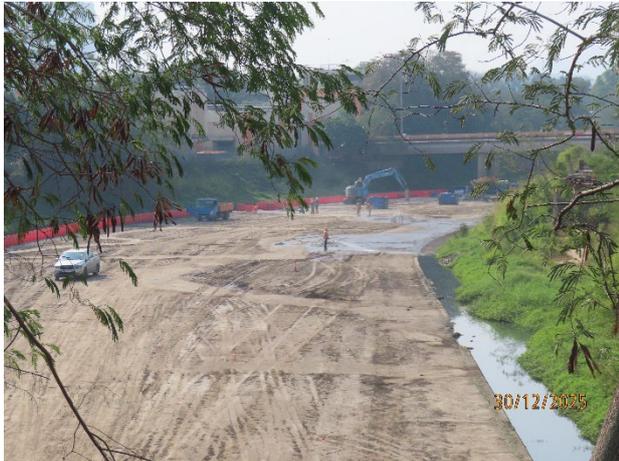
- 5.2.11 The construction works by other Project, was also observed in the main channel of Shek Sheung River at P5, where excavators were observed to be driven on the channel, since the survey on 18 November 2025. Excavators were also observed to have entered P5 via access of P6 since the surveys on 14 November 2025.

Photo 5 Site clearance of unknown party at P5 (30/12/2025)	Photo 6 Eastern Cattle Egret at T2 (24/12/2025)
