JOB NO.: TCS01216/21

WSD Contract No.: 3/WSD/20 -

Reclaimed Water Supply to Sheung Shui and Fanling

MONTHLY ENVIRONMENTAL MONITORING & AUDIT REPORT (NO.24) – NOVEMBER 2023

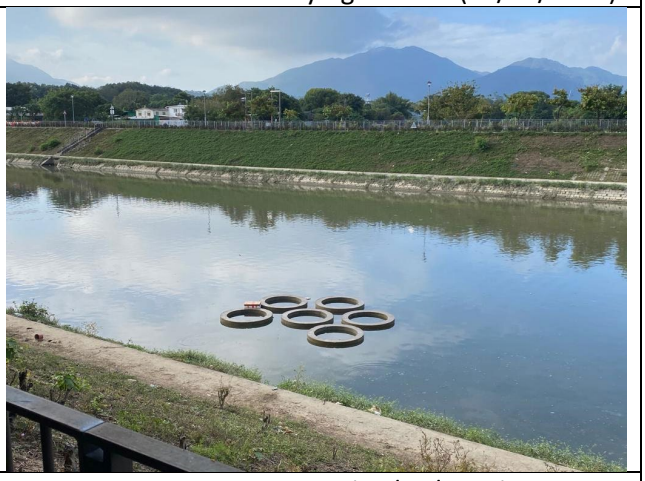
Photo 5 Fishing at P4 (24/11/2023)	**Photo 6** Collared Crow at P6 (24/11/2023)
