**WSD Contract No.: 3/WSD/20 -
Reclaimed Water Supply to Sheung Shui and Fanling**

**MONTHLY ENVIRONMENTAL MONITORING & AUDIT
REPORT (NO.15) – FEBRUARY 2023**

**PREPARED FOR
WATER SUPPLIES DEPARTMENT**

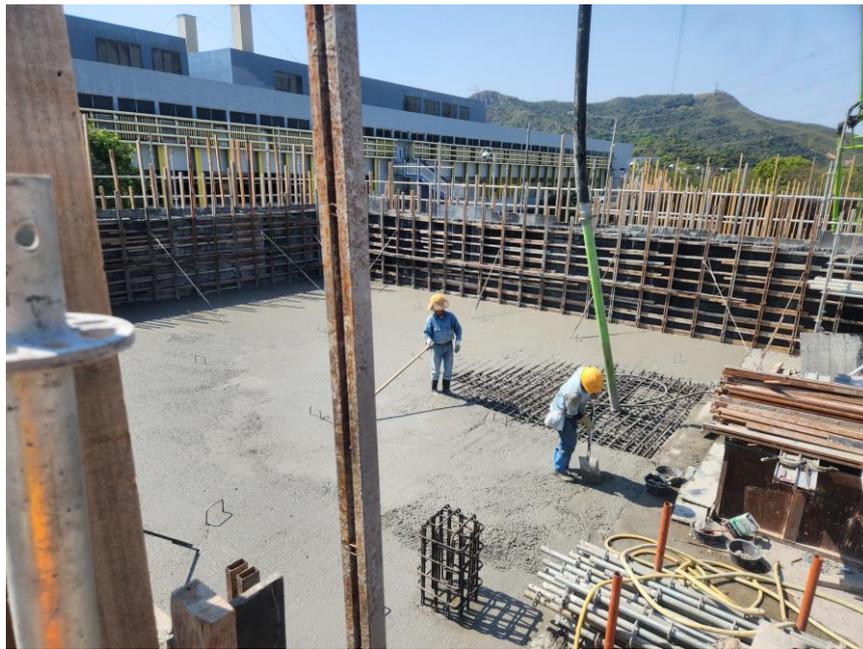
R.C. Structure of HCF - Concreting work at Roof Floor

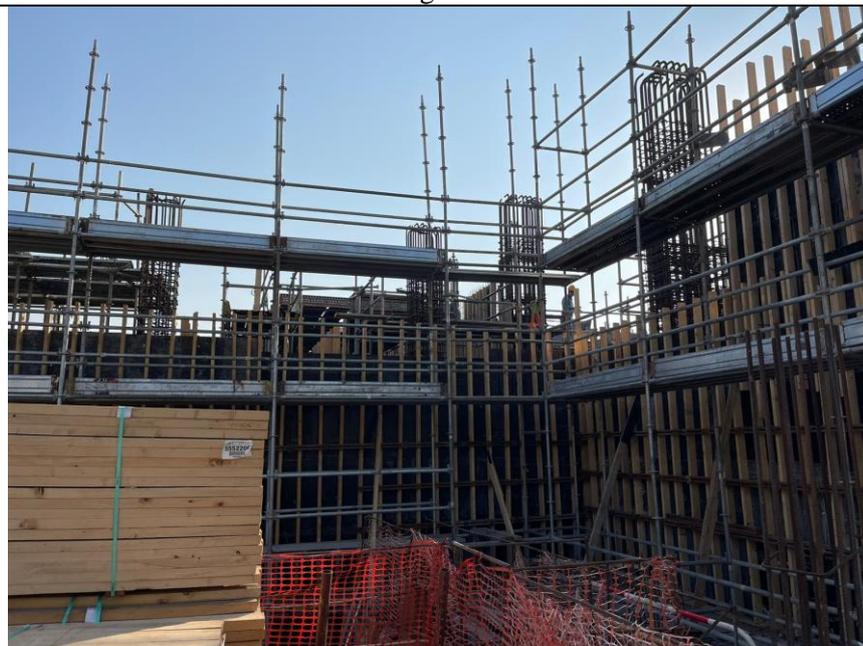
R.C. Structure of ReWPS - Formwork Erection and rebar fixing work for Wall & Column up to Corbel

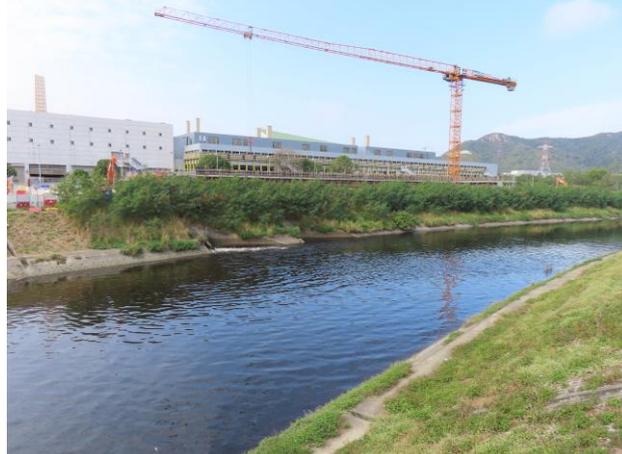
<p>Photo 1 Works on current project at P4 (3/2/2023)</p>	<p>Photo 2 Concrete Blocks laid by DSD and damming at P2 (21/2/2023)</p>

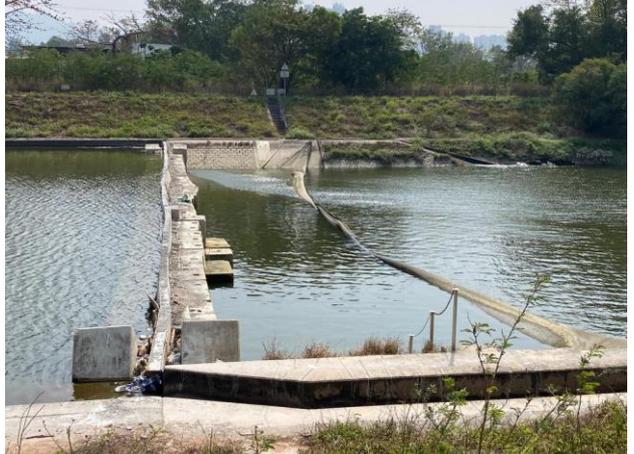
- 5.2.6 Concrete blocks laying work was observed across Ng Tung River at P2 and P3 by other Project since November 2022. It was observed during the survey in the reporting period that a barrier was constructed on the concrete blocks, and the gathered water is now directed to a low flow channel that leads to a lower part of the river. Hence, it is expected that the water level of Ng Tung River along T1 (P1 and P2 included) will now be permanently higher than the baseline survey, which may reduce the foraging area at P1 and/or P2 and attract less waterbirds to forage at these two points.

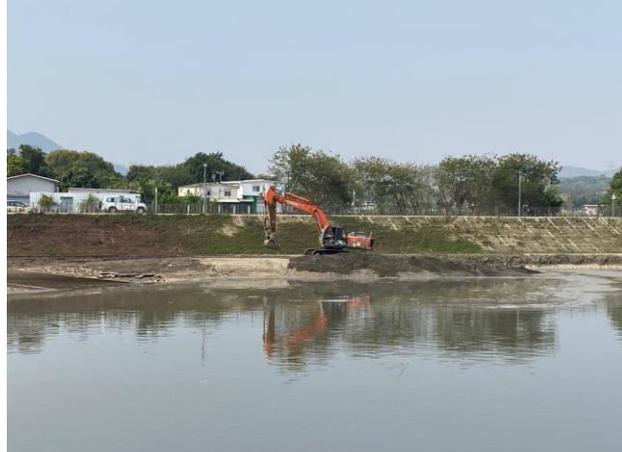
- 5.2.7 Construction involving excavators by an unknown party were observed to be operating near P6 since the survey in Mid-February 2023. At the same time, sediments piles were observed in the river in T3 close to P6, and thus the sediment piles are believed to be related to the construction by the unknown party. The increased water level as a result of accumulation of sediments would decrease area available for foraging waterbirds and activities of excavators are believed to be a source of disturbance that may discourage waterbirds from foraging near P6.

- 5.6 Additionally, construction involving excavators by an unknown party were observed to be operating near P6 since the survey on 17th February (indicated in Photo 3 of **Appendix D**). At the same time, sediments piles were observed in the river in T3 close to P6 (Photo 4 of **Appendix D**), and thus the sediment piles are believed to be related to the construction. The increased water level as a result of accumulation of sediments would decrease area available for foraging waterbirds and activities of excavators are believed to be a source of disturbance that may discourage waterbirds from foraging near P6.

<p>Photo 3 Slope construction by an unknown party at T3 near P6 (21/2/2023)</p>	<p>Photo 4 Accumulation of sediments at T3 (17/2/2023)</p>
