**WSD Contract No.: 3/WSD/20 -
Reclaimed Water Supply to Sheung Shui and Fanling**

**MONTHLY ENVIRONMENTAL MONITORING & AUDIT
REPORT (NO.26) – JANUARY 2024**

**PREPARED FOR
WATER SUPPLIES DEPARTMENT**

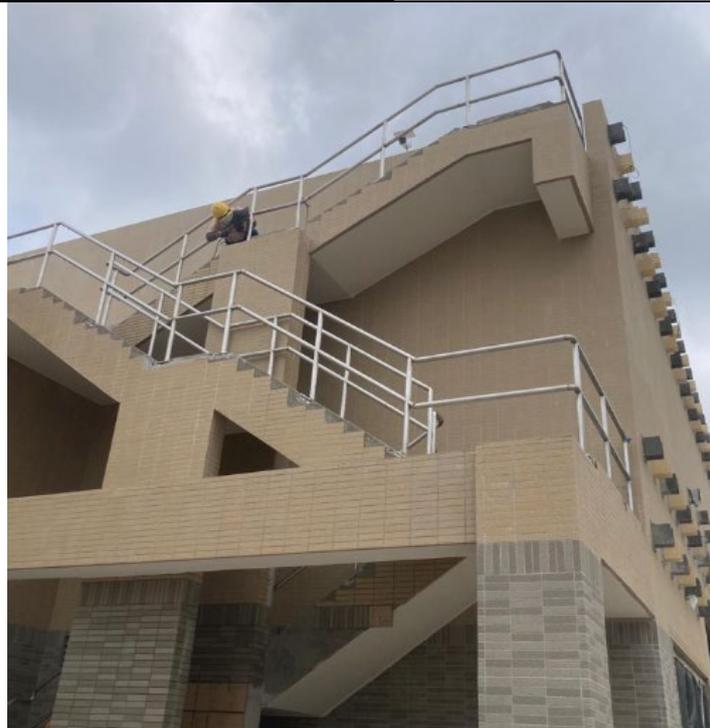
Installation of Railing and Windows

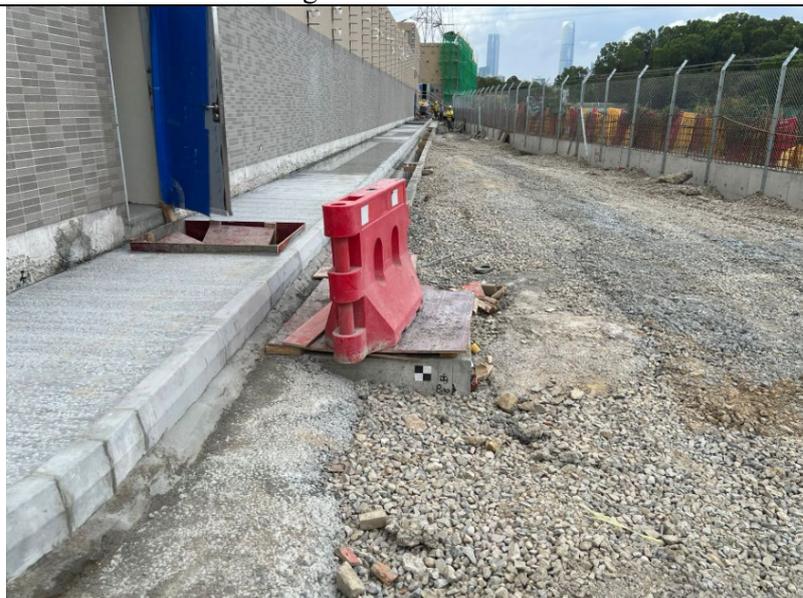
Construction of Pavement and Road Kerb

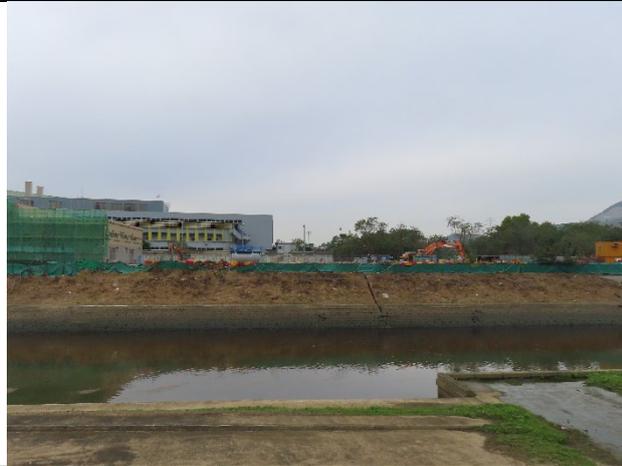
<p>Photo 1 Works on current project at P4 (30/1/2024)</p>	<p>Photo 2 Road enhancement and sewerage system upgrade works by DSD at T2 (19/12/2023)</p>

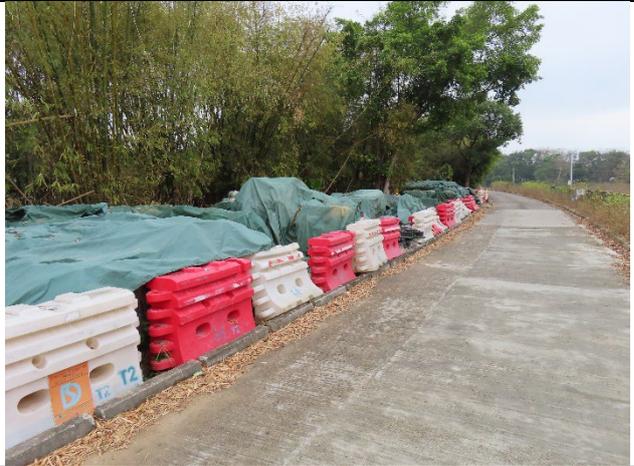
- 5.2.6 Road enhancement and sewerage system upgrade works by other Project along T2 near P3 was observed to have ceased operation during the survey on 30th January 2024. However, materials and machinery were still on site and covered by tarpaulin.

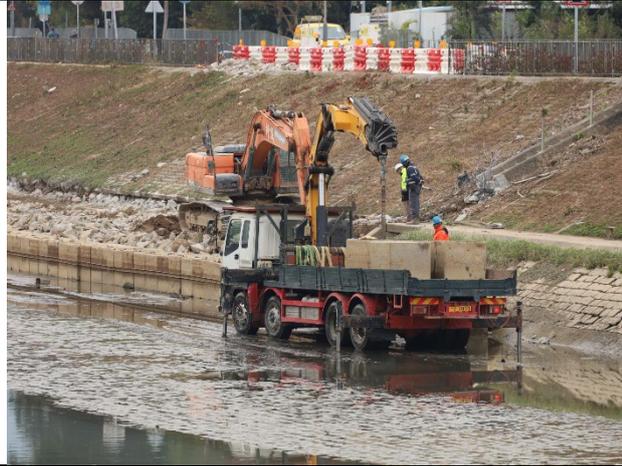
<p>Photo 3 Concrete block laying involving a truck at T3 (26/1/2024)</p>	<p>Photo 4 Concrete block laid at P6 (26/1/2024)</p>

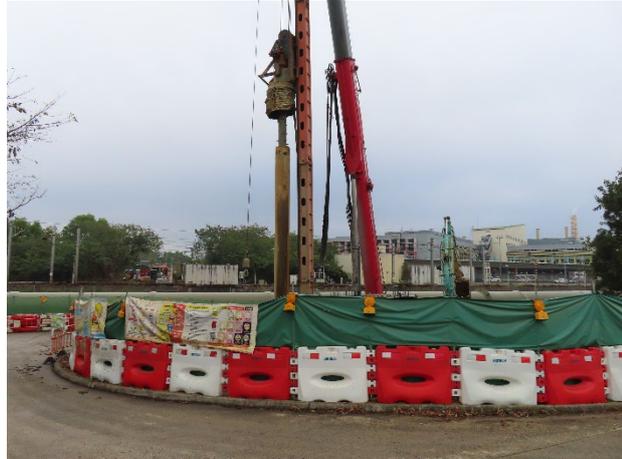
- 5.2.10 The unknown construction works by other Project was observed to have started since the early January 2024. The construction was located in a cleared area between Sheung Yue River and the Sheung Shui Slaughterhouse, and involved excavation and drilling works.

<p>Photo 5 Drilling machine and excavator at BKREJV construction site at T3 (30/1/2024)</p>	<p>Photo 6 Grey Heron at P7 (2/1/2024)</p>

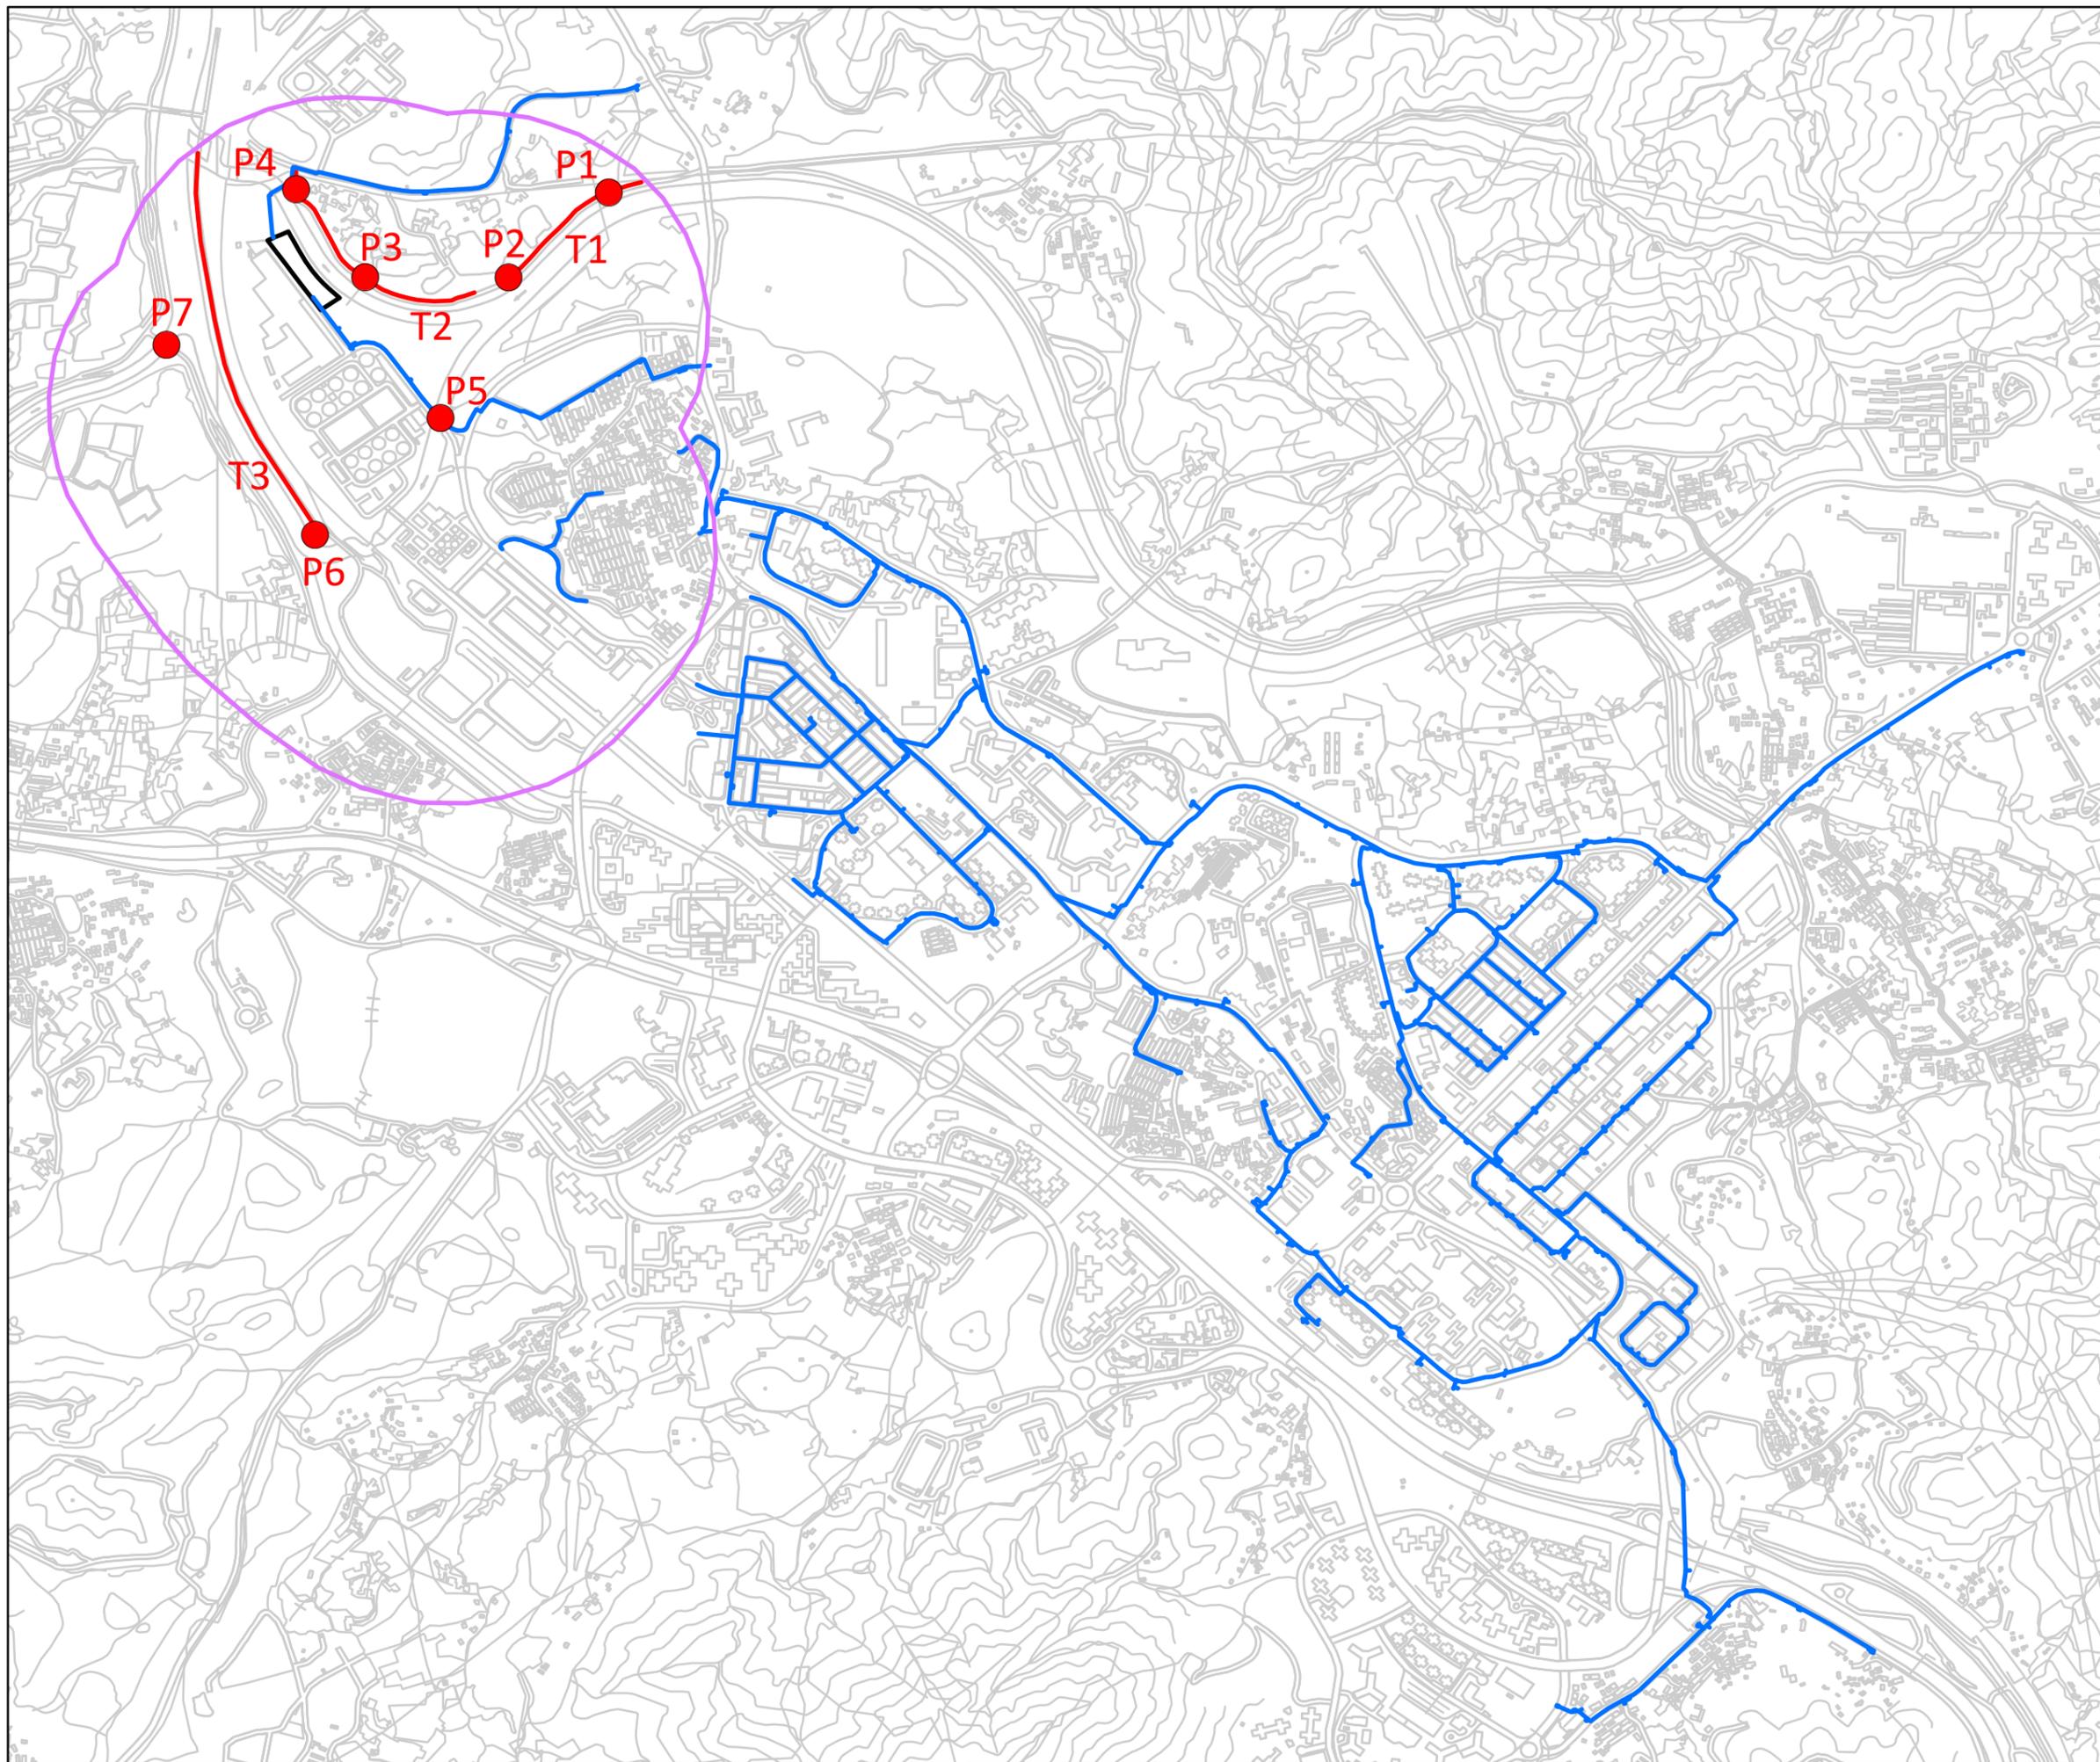
Figure 1
Transect and Point Count Location

- Proposed Shek Wu Hui Water Reclamation Plant
- 500m Survey Boundary
- Proposed Retained Water Mains
- Walk Transects
- Point Count Locations

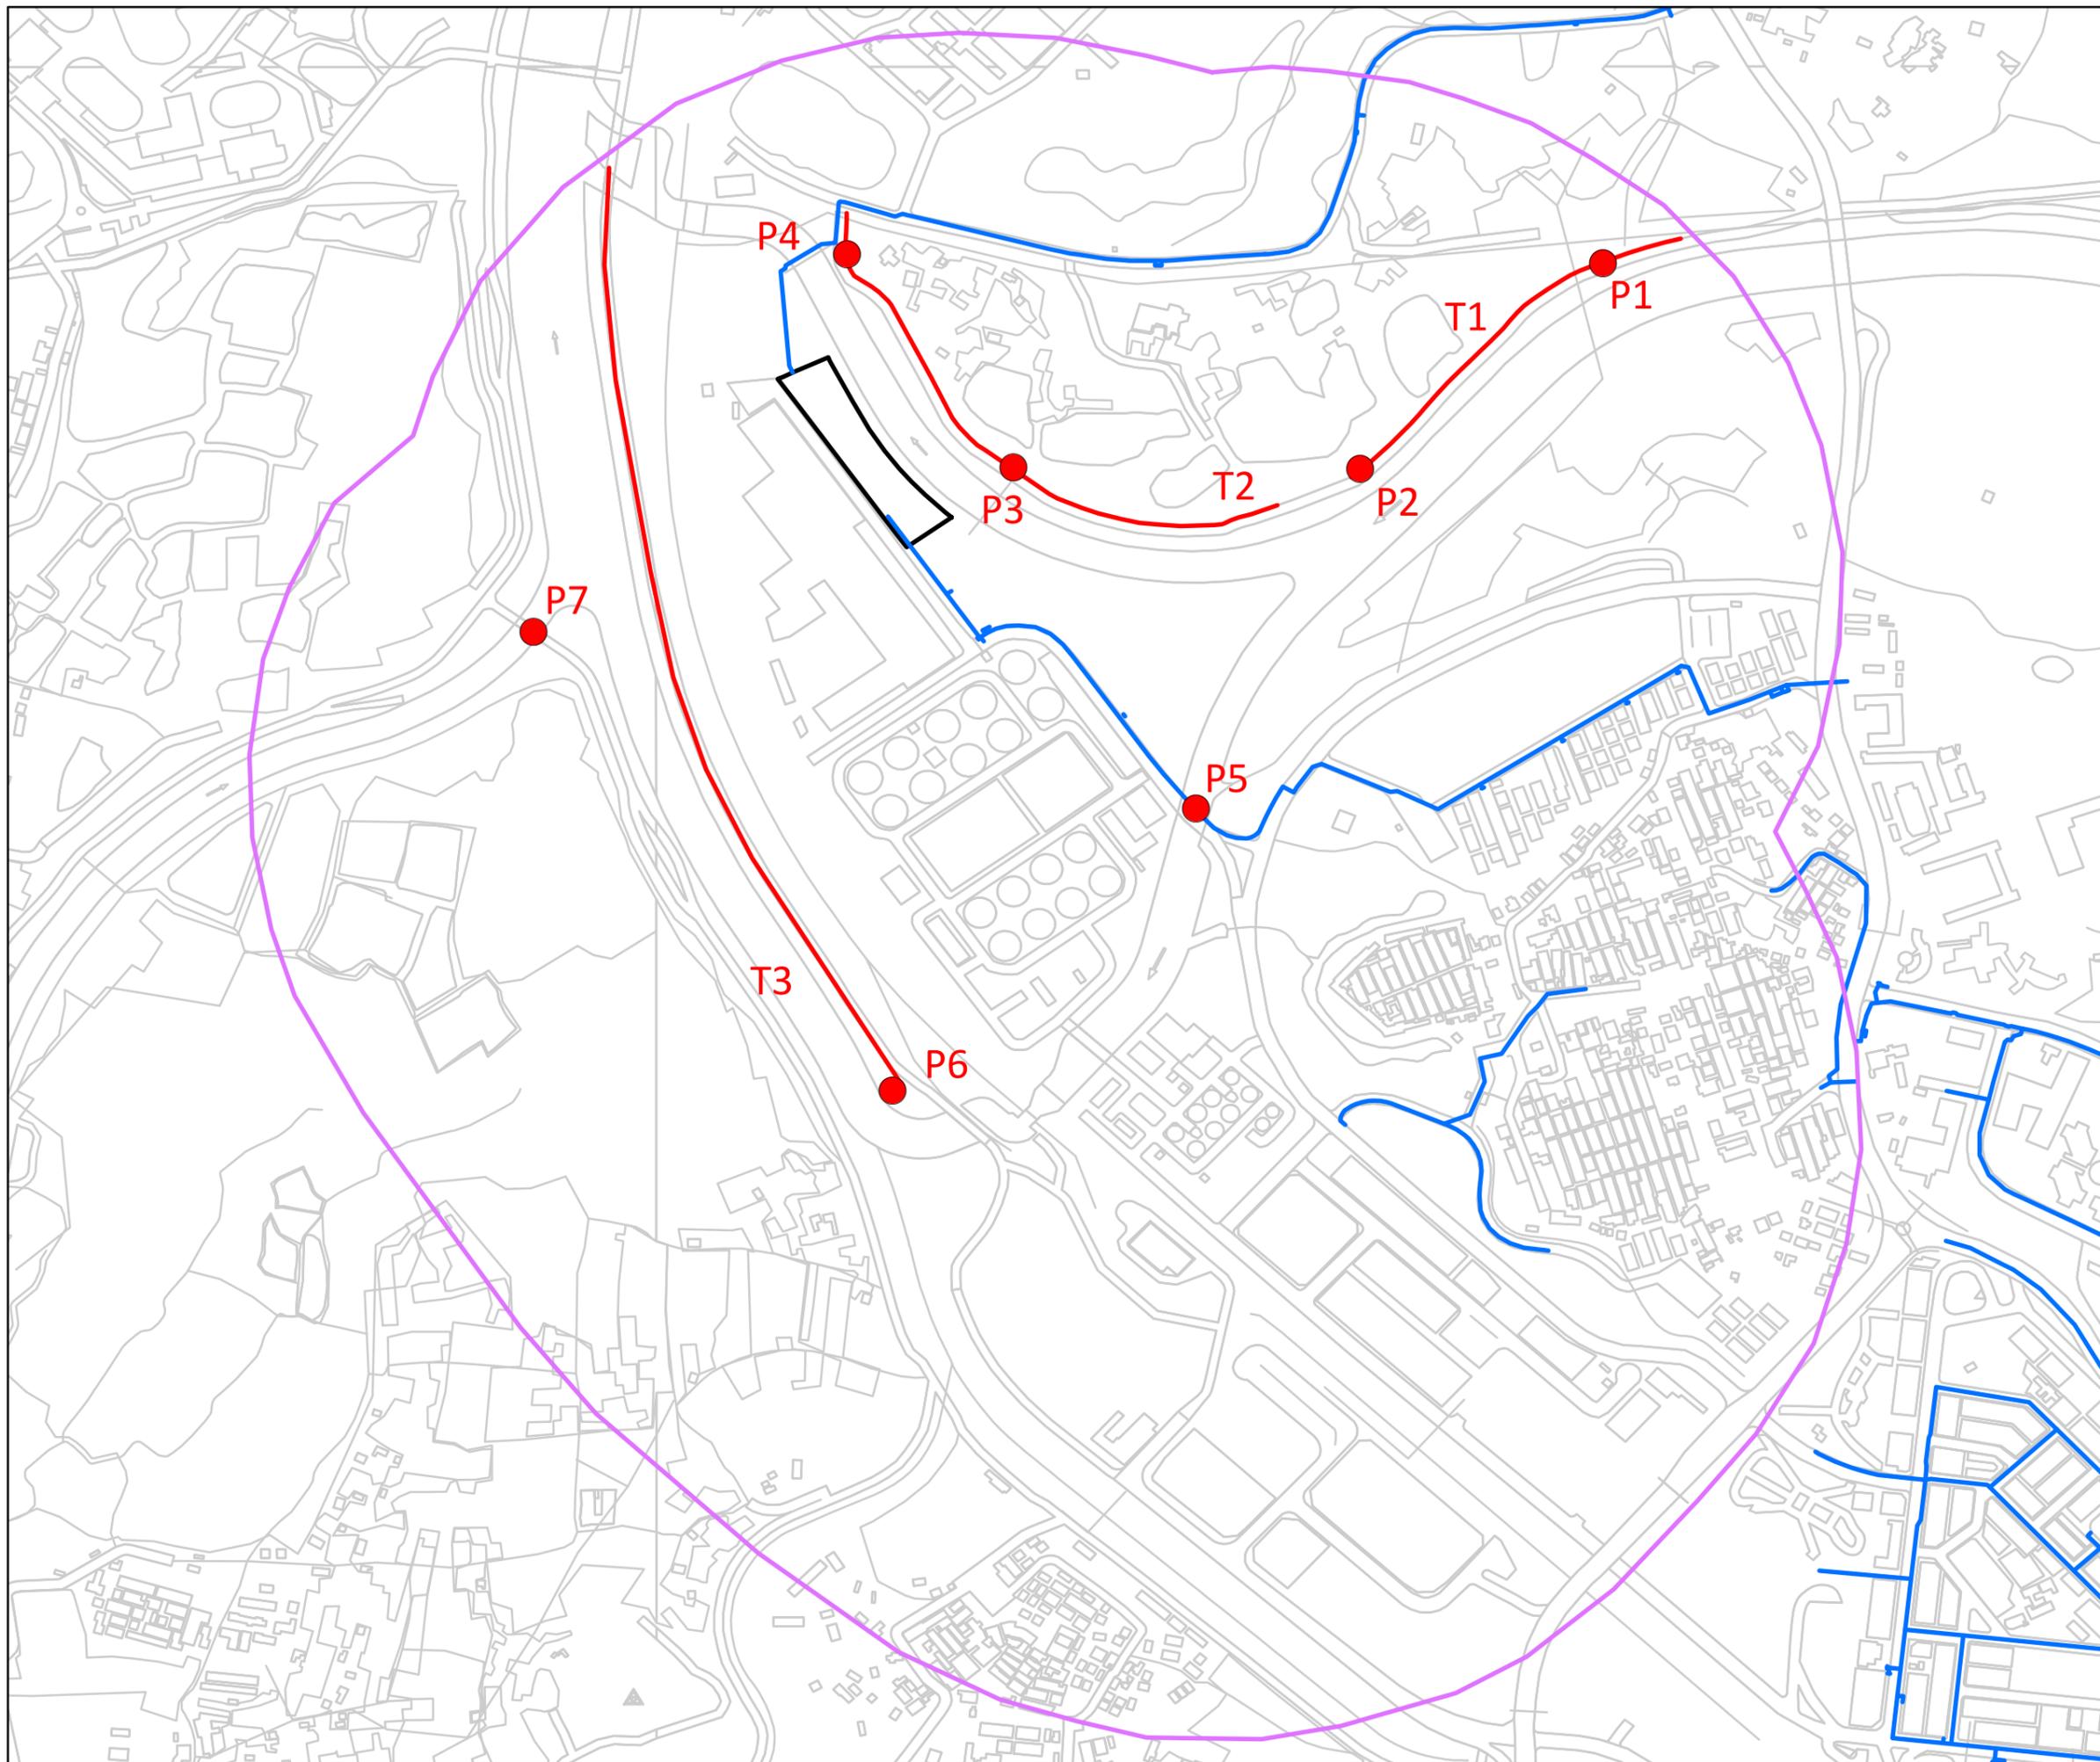
Figure 1a
Transect and Point Count Location (Zoomed In)

- Proposed Shek Wu Hui Water Reclamation Plant
- 500m Survey Boundary
- Proposed Retained Water Mains
- Walk Transect
- Point Count Locations
